Product Change Notification

PCN No: 2006-12-07-01

Subject: GLK12232-25-SM PCB 1.4 I2C Changes

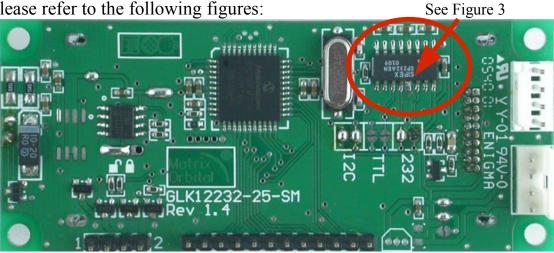
The GLK12232-25-SM PCB 1.4 requires a special procedure in putting the module in I2C mode.

Figure 1: GLK12232-25-SM PCB 1.4 I2C changes

- 1) Solder both I2C pads (2 pads)
- 2) Solder left 232 pad (1 pad)
- 3) Lift pin 13 of the SP232AEN IC pin 13 is counted from top right counter clockwise as Figure 1 indicates (please note the board's orientation)

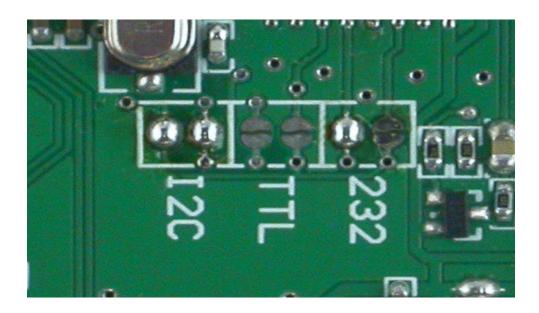
Figure 2: Pads to Solder

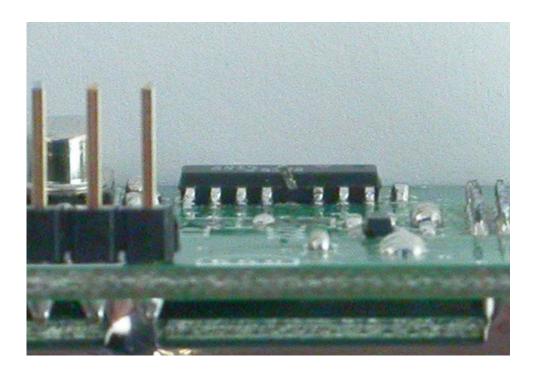
Figure 3: Pin 13 of SP232AEN IC lifted
